THE KNOWLEDGE OBTAINED FROM THE MAIN INSPECTIONS OF PEDESTRIAN BRIDGES IN PREŠOV

Purpose of the study. This study sums up the most severe faults on selected pedestrian bridge structures and provides findings acquired during the inspections.

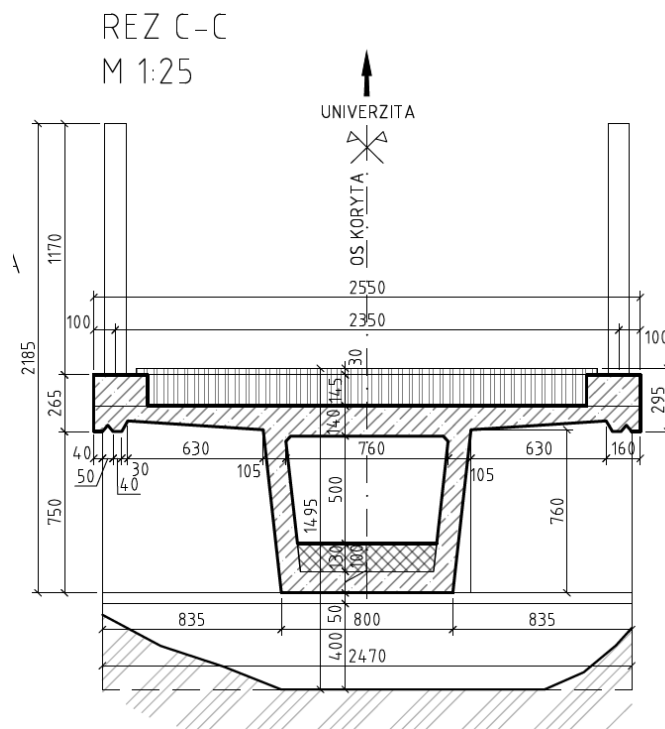
Results of the study. *Assessment of defects of pedestrian bridges. Segmental pedestrian bridge next to the University of Prešov.* The pedestrian bridge structure consists of concrete segments fastened together with prestressing tendons located in the chamber. The tendons near the bottom slab are covered with additional cement filling (Fig. 1).

Fig. 1. Schematic cross-section of the structure

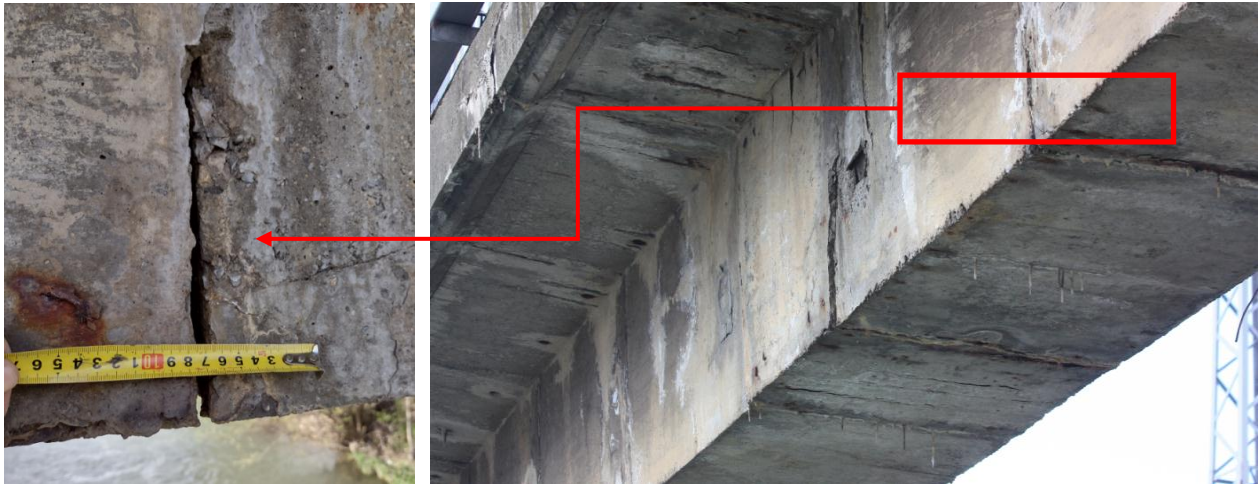
On inspection of the bridge, a significant deflection was visible. This deflection was noticeable on the bottom slab and the bridge's handrail. After a more detailed inspection of the structure, it was discovered that the opening of joints at the contact of beam segments occurred (10 – 15mm) in the middle of the second span. This phenomenon indicates problems with prestressing reinforcement (Fig. 2). After removing the inspection holes in the area of the abutments, it was found that the filling mortar had completely deteriorated due to the very high humidity and freezing cycles.

Fig. 2. Opening of the joints between the segments in the middle of the second span

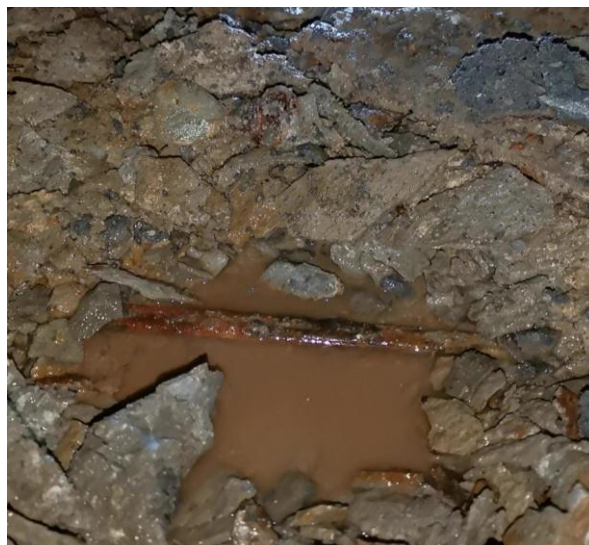
Cementitious mortar, initially protecting prestressed reinforcement, is cracked, carbonated (on-site test on fragments by 1.0% phenolphthalein solution) and does not fulfil its protective function. Water is held in the bridge chamber due to the absent drainage of the chamber. Due to the water, the mortar and the prestressing reinforcement has completely deteriorated in the chamber. Prestressing reinforcement is a critical load-bearing element in this type of structure, and corrosion significantly decreases the bridge's load-bearing capacity (Fig. 3). This state is also supported by noticeable deflection generated by the structure's dead load. The opening of joints between segments accelerates local corrosion of prestressing tendons. Due to the facts mentioned above, the pedestrian bridge was immediately closed to pedestrian traffic.

Fig. 3. Corroded prestressing reinforcement

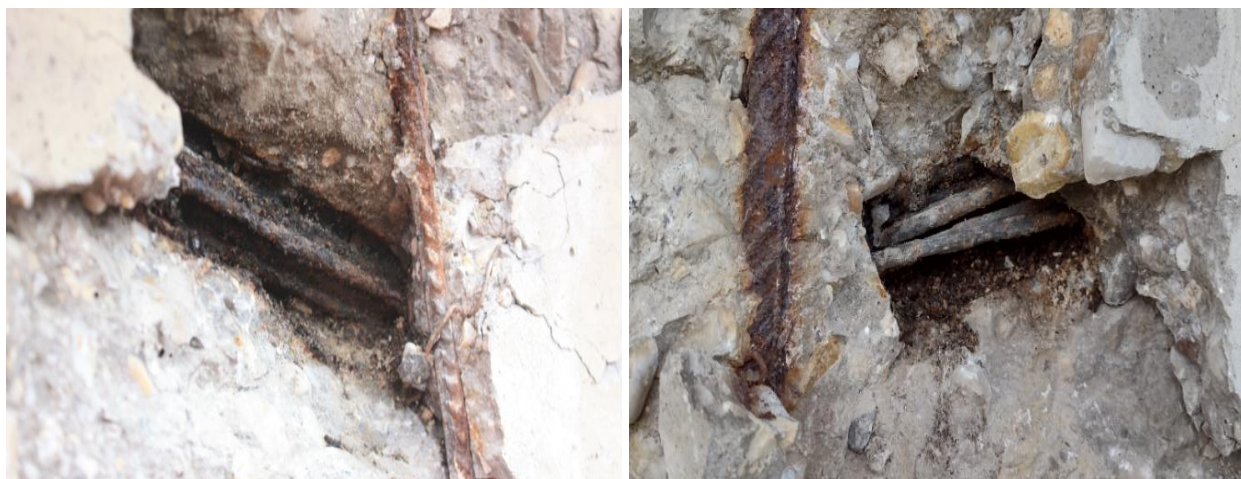
fastened together with prestressing tendons. The length of the beams is 37 m. Their lower and upper flanges are not concreted and thus not connected. Other than lowered cooperation of beams, limited within thin concrete slab constructed above the upper flange, corrosion of stirrups sticking out of beams occurs. These stirrups were to bind a reinforcement of a prefabricated beam with concreting between beams. There are visible cracks parallel to prestressing tendons on the walls of the beams. Non-grouted prestressed reinforcement with advanced corrosion was discovered after removing the delaminating concrete cover layer (Fig. 4). There is a high probability of water leaking into non-grouted ducts, which subsequently freeze in winter. Consequently, the water expands in a narrow duct space and generates cracks parallel to prestressing reinforcement. This phenomenon indicates a problem with the waterproofing of the bridge. The leaking water transports chloride ions from deicing salts along cable ducts.

For both bridges, the permissible chloride levels in the concrete for prestressed structures were exceeded several times according to EN 206 [7]. The permeated chlorides act as a corrosive catalyst, making corrosion progress more rapid due to the lack of diffusive protection around the prestressing tendon. This protection usually consists of a highly alkaline grouting compound. It is assumed that most cable ducts are not grouted or are grouted with poor quality grouting compound, which significantly increases the risk of corrosion of the prestressing reinforcement and thus increases the likelihood of a possible sudden collapse of the structure. Due to advanced corrosion of the exposed prestressing cables, both bridges were immediately closed. They will have to be rebuilt, as they threaten train traffic passing under the bridges.

Fig. 4. Non-grouted cable ducts with corroding prestressing reinforcement

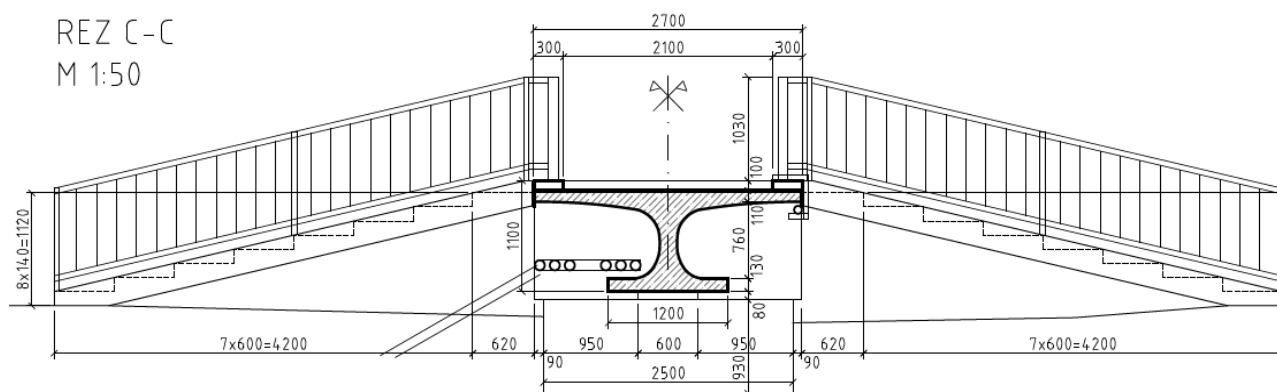
Pedestrian bridge over the Torysa river on Mukačevska street. The pedestrian bridge made of an atypical, prestressed concrete beam with a total length of 39.25 m and a height of 1.0 m indicates excessive cracks with a width of 2 mm at the working joints, approximately 3 m from the piers. The anchors of the prestressing reinforcement and the anchored prestressing cables are visible in the joints, insufficiently grouted and partially corroded (Fig. 5). However, the bridge slab does not show excessive deflections. The approach ramps with stairs have deteriorated significantly, and their reinforcement is massively corroded due to inadequate concrete cover, probably also due to manufacturing defects. The abutments show significant concrete deterioration and corrosion of the steel reinforcement due to leakage. The bearings on the abutments corrode. The bridge has been closed to the public due to non-grouted prestressing tendons and the disrepair of the access stairways.

Fig. 5. Schematic cross-section by abutment

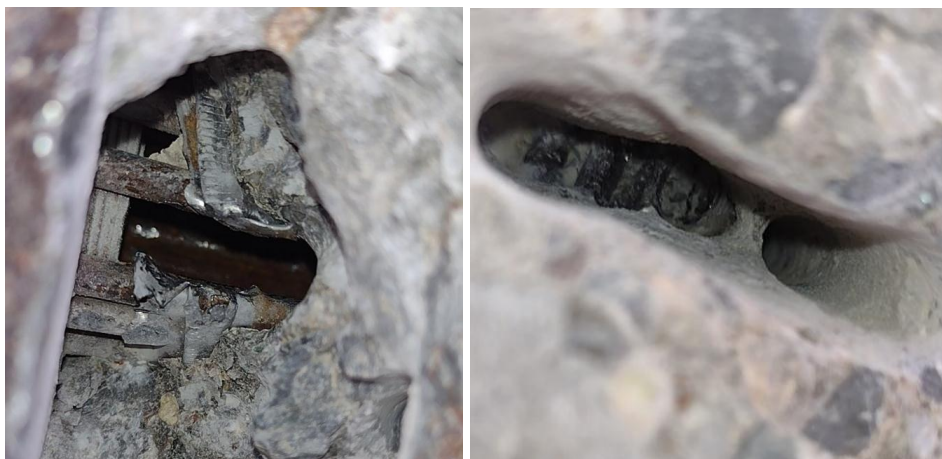
Concrete samples taken from the ledges, under the asphalt and from the bottom slab did not confirm excessive chloride content in the concrete, probably due to the lower intensity of winter maintenance. Prestressing tendons corrode significantly slower, although they are not grouted with cement (Fig. 6). The low chloride contamination of the concrete creates good preconditions for the reconstruction and further functioning of the bridge. The bridge has already been reconstructed and reinforced with free-running external prestressing cables.

Fig. 6. Non-grouted prestressing tendons in the bottom slab of the precast concrete; left – anchorage point, right – approx. 0.5 m behind the anchor
