STRUCTURAL ASSESSMENT OF THE BRIDGE № M 044 AT THE END OF RYBNIČNÁ STREET ABOVE THE ROAD II/502 BRATISLAVA-PEZINOK

Abstract. The paper is focused on the results of the survey and diagnostics of the bridge № M 044 at the end of Rybničná street above the road II/502 Bratislava-Pezinok in the Slovak Republic. The article is the result of the cooperation between the Department of Concrete Structures and Bridges of the Slovak Technical University in Bratislava and the Department of Reinforced Concrete Structures and Transport Facilities of the Odessa State Academy of Civil Engineering and Architecture within the framework of the National Scholarship Program of the Slovak Republic. Data were obtained to assess the technical condition of the structures and the bridge as a whole. As a result of the inspection, the type of destruction of each structural element of the frame and superstructure was determined. A study on the content of chloride-ionic contamination of concrete and non-destructive tests of strength parameters was carried out. A detailed research analysis of the results and recommendations for processing the reconstruction has been proposed. In accordance with the valid regulat

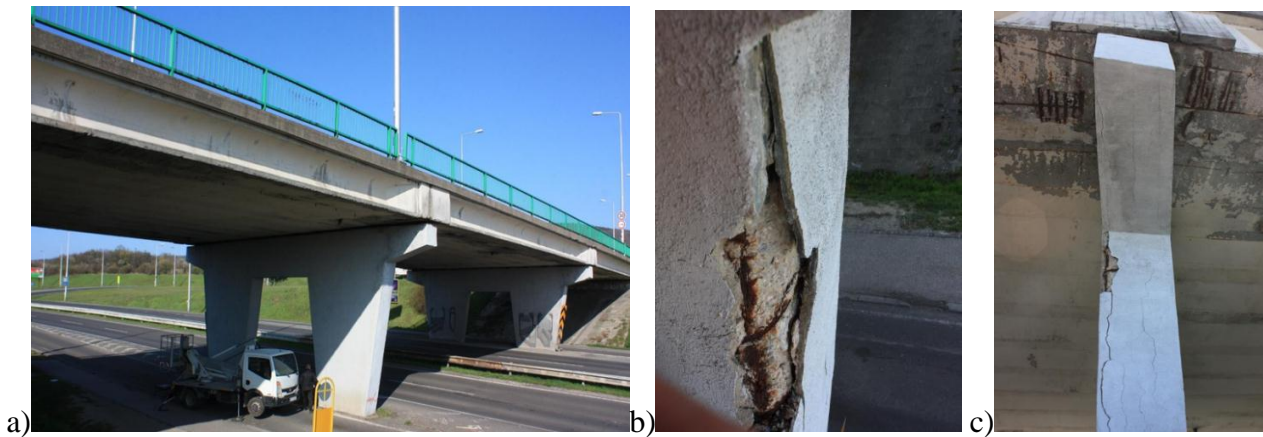
The piers show advanced corrosion of the reinforcement at the flow points, as a result of which the cover layer delamination occurs (Fig. 3). Due to the corrosion of the reinforcement, there are in some places wide longitudinal cracks within the piers head. It is assumed that there is a high concentration of chlorides in these places of the pier, which will continue to cause corrosion of the reinforcement, even if the flow of the piers would stop completely.

Fig. 3. View of the bridge (a); condition and failures of the substructure (b, c)

Corrosion of the main load-bearing reinforcement within the pier head on the short console is progressing in some places, with a cross-sectional weakening of approximately 30% with significant delamination of the cover layer, which significantly reduces the cohesion of concrete with reinforcement.

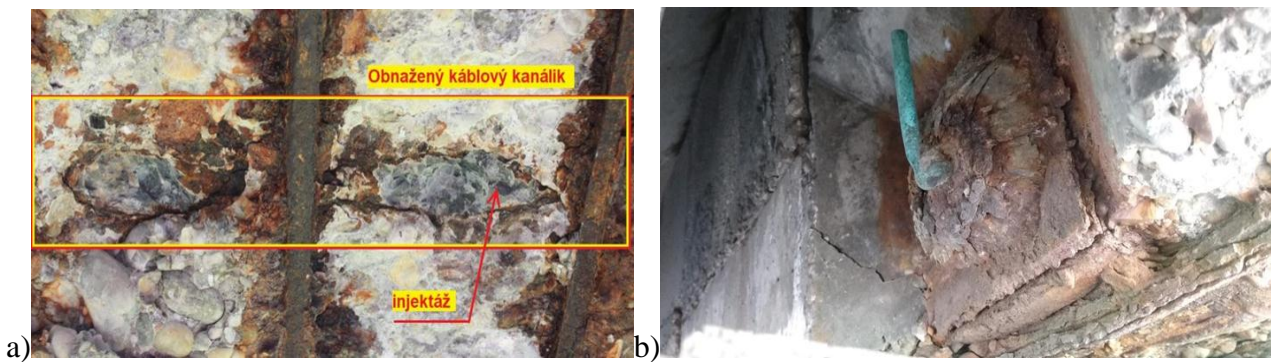
Locally, especially in places of intensive inflow of end beams, reinforcement is exposed and corroded (Fig. 4, a). The exposed prestressing reinforcement has so far been free of corrosion. The controlled tendon ducts were grouted with a fine injection material. There is no local concreting of the anchors of prestressing reinforcements, which corrode intensively (Fig. 4, b). Some beams have a longitudinal crack at the top of the lower flange – it is assumed that this is a manufacturing error.

Fig. 4. Intense corrosion of the exposed reinforcement (a); prestressing reinforcement anchor (b)

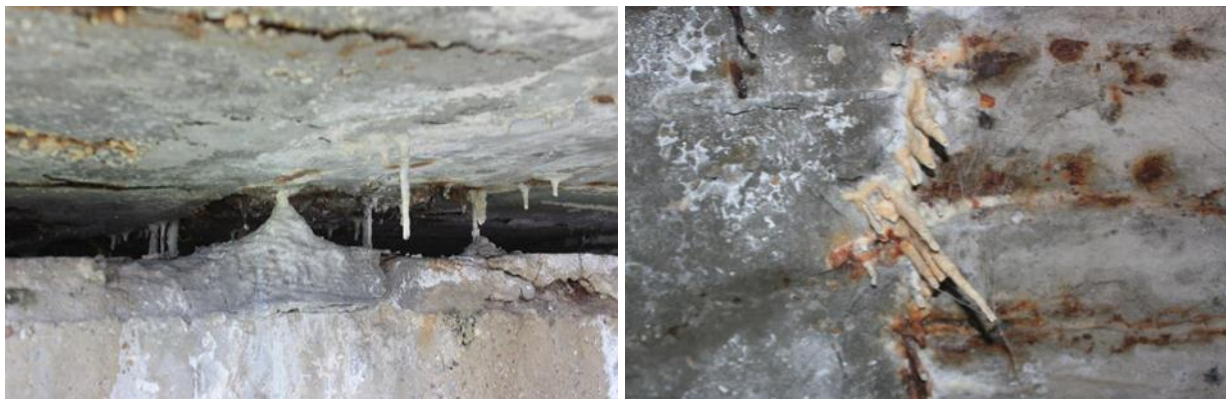
Intensive leakage of the structure, which occurred during the operation of the bridge (Fig. 5) caused contamination of the structure with chloride ions. It is, therefore, assumed that the corrosion of the reinforcement will continue even if the leakage is eliminated, but the reduction of moisture will significantly slow down the corrosion process. It is therefore necessary to inspect the structure even after heavy rains and to identify places where leaks still occur and repair these places.

Fig. 5. Intensive leakage of the structure

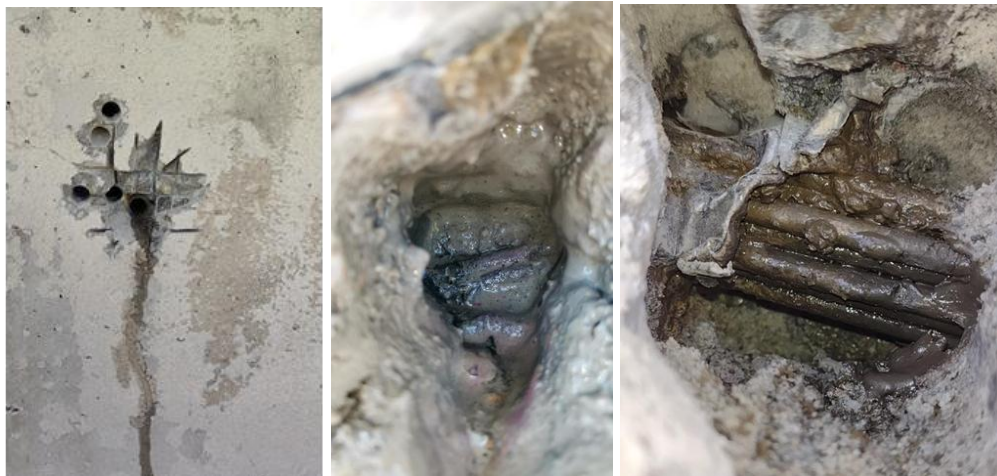
Some end beams show cracks copying the position of the tendon ducts of the prestressing reinforcement. After drilling them, water leaked from the tendon ducts, which indicates un-grouted tendons. The prestressing reinforcement was not corroded at either point on either of the two tendons (Fig. 6). The sample taken from the inside of the tendon duct showed only a slightly increased concentration of chlorides up to about 0.4% by weight of the cement. The probe sites were subsequently repaired with a cement-based repair compound.

Fig. 6. State of prestressing reinforcement in tendon ducts from which water leaked after drilling
