GEODESIC MONITORING DURING TEMPLE RESTORATION

Odessa State Academy of Civil Engineering and Architecture

Abstract. During the construction and reconstruction of real estate and especially monuments of architecture, it is necessary to conduct geodetic monitoring. These are observations of the deformations of buildings during the construction process. Such monitoring allows you to determine the causes of deviations from the design and look ahead predicting their development, as well as provide recommendations and appropriate measures to prevent critical situations that can lead to irreparable consequences.

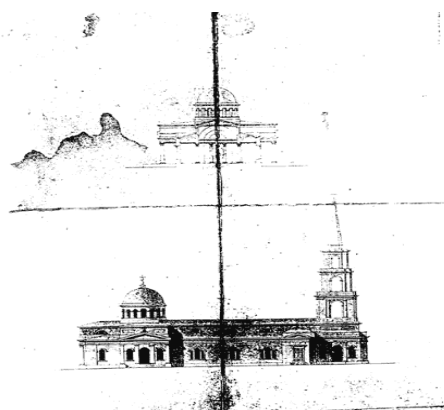
Fig. 5. The project of the front and a sectional arrangement of the refectory of the saviour's Transfiguration Cathedral in 1841

of the Archbishop of Kherson and Tavria Gavriil (Rozanov) in 1841 an architect D. Geidenreich made a project of a refectory, which combined the bell-tower and the old Church (Fig. 4, 5).

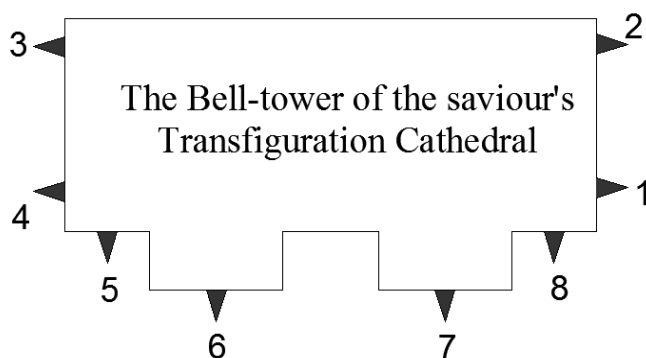
Fig. 12. The diagram of fixing deformational benchmarks on the bell-tower of the saviour's Transfiguration Cathedral

The investigation results. Geodetic observation the settlement of the bell-tower footing was performed by fourteen cycles after the finishing of the building. Eight deformation benchmarks were set on the front and in the lower part of the building around the entire perimeter, which were under the observation for over a year. The places of the precise location of the benchmarks are fixed at the diagram of the bell-tower (Fig. 12).

Deformational benchmarks are the control geodetic benchmarks which are located on buildings and constructions for which the vertical movements were identified [2-5]. The observational interval is one month.

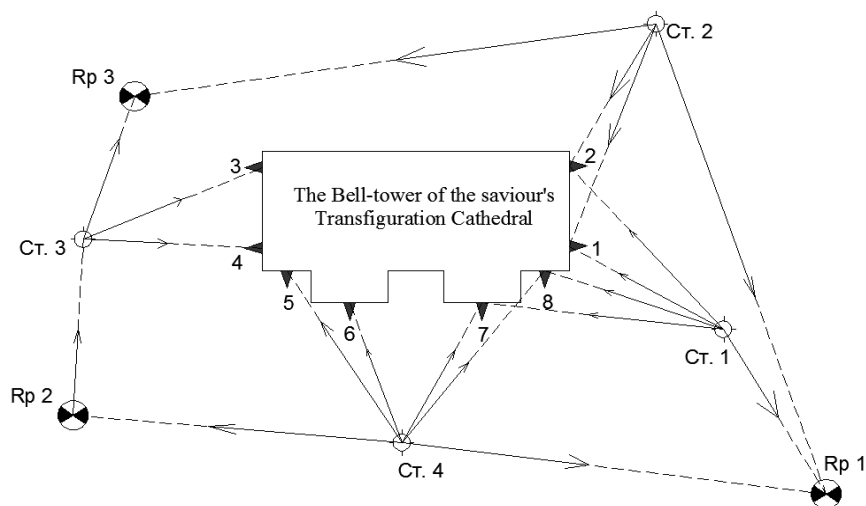
Fig. 13. The diagram of location of lubber lines and stations as related to the bell-tower of the saviour's Transfiguration Cathedral

The observation of the deformational benchmarks was carried out by geometric leveling of the class III (Fig. 13), which is used with vertical moving of the footing base, according to the regulatory documents [4, section 10]:

Before the beginning of measurements, three ground bench marks were fixed on the ground – Rp.I, Rp.II, Rp.III, which were tied to the input bench mark line with a known mark of the urban vertical control survey network [3, section 6]. The lubber lines were located aside on passages, underground utility systems, open storages, outside zones of extension of pressure from building and constructions, outside the borders of influence from settlement phenomenon, landslides, slopes, unstabilized mounts at the distance from buildings (constructions) not less than triple wise width of the level of the ground, which settles and at the distance which includes influence of vibration from transport, cars, machines in places where during the entire period of observation an unhampered and comfortable access to the bench mark lines is possible for setting geodetic instruments [3, 5]. The measurements were performed not earlier than 10 days after setting the signs.

Leveling of deformational benchmarks was performed from four (St.1, St.2, St.3, St.4) constantly fixed stations. When performing the measurements there was no possibility to control inequality of the shoulders (distance to the rod), therefore the method of «a short ray» was applied – the distance to the rod didn't exceed 25 m, the height of the ray from the ground surface didn't exceed 3 m with fairness distance of the rays from surrounding items more than 0.5 m. The average quadratic deviation of geometric leveling at the station along with intrinsic convergence was 0.3-0.5 mm [1, 5].

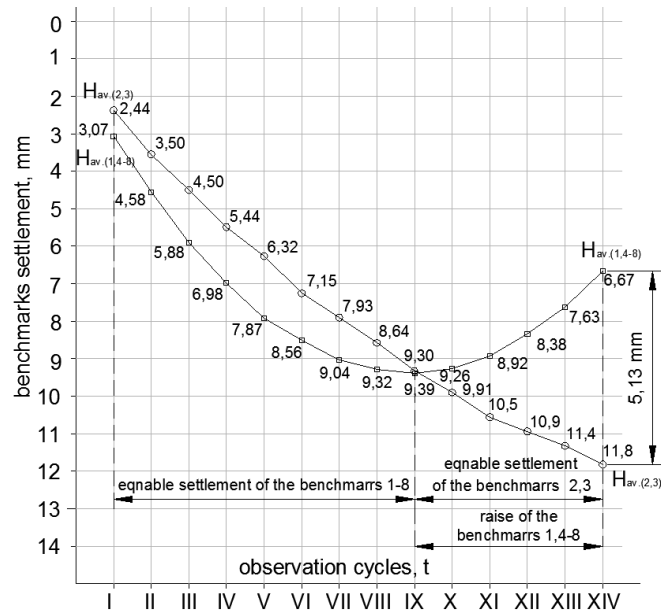
Fig. 14. The assay of experimental and functional dependences $H_{av.}(2, 3)$ та $H_{av.}(1, 4-8)$

From the opposite side of the bell-tower another way of settlement was observed, there were the benchmarks 1, 4-8. From the third cycle to the sixth cycle they gradually settle in average by 0.55 mm, and from a the sixth cycle of the observation to the fourteenth cycle a gradual raising of these deformation benchmarks of the base of the footing in average by 1.27 mm was observed, since a monolithic concrete slab of the bell-tower footing gets an insufficient inclination due to additional loading from the benchmarks 2, 3 during building the main building of the Church (Fig. 14).

But in the confident conclusion about the progressing or damping character of the deformation benchmarks settlement some statistic consistent patterns were set and graphs of experimental and functional dependences were composed correspondingly (Picture 16-17), which correspond to the quadratic dependence of the type:

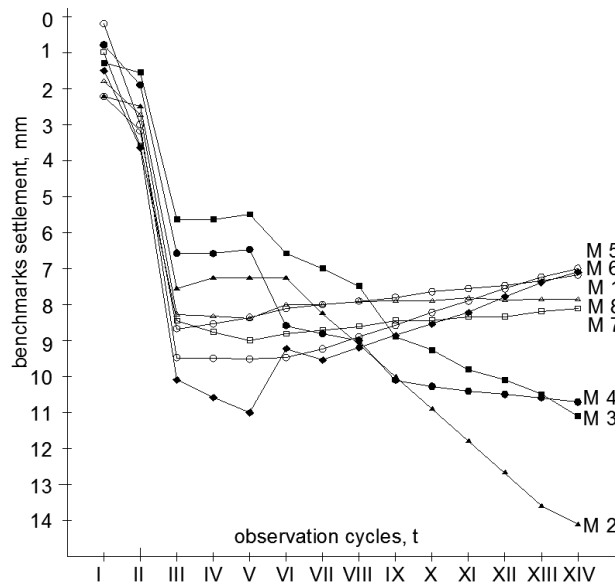
Fig. 15. Settlement progress of eight deformation benchmarks for the period from 9.01.2001 to 10.02.2002

The consecution of the settlement of all deformation benchmarks is presented in the Picture 15, which shows inequality of the settlement. A consistent pattern of the rapid settlement of the

benchmarks 2, 3 in average for the entire period by 7.66 mm with gradual decreasing, and settlement of the benchmarks 1, 4-8 to the contrary – gradually comes to raising.

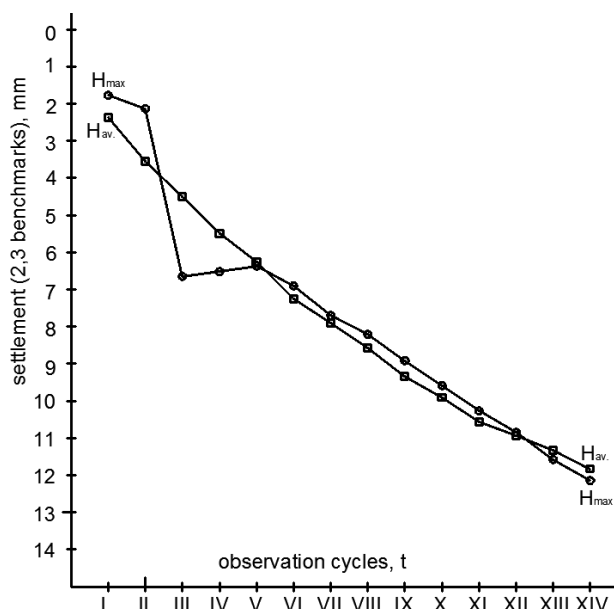
Fig. 16. The graph of experimental and functional dependences of the deformation benchmarks 2, 3

$$H = -0,02826t^2 + 1,14t + 1,33; \tag{2}$$

After forecasting the settlement of the base of the footing of the deformation benchmarks 2, 3 it was obtained that after 20,2 months their average settlement will stop, having reached 12,8 mm.

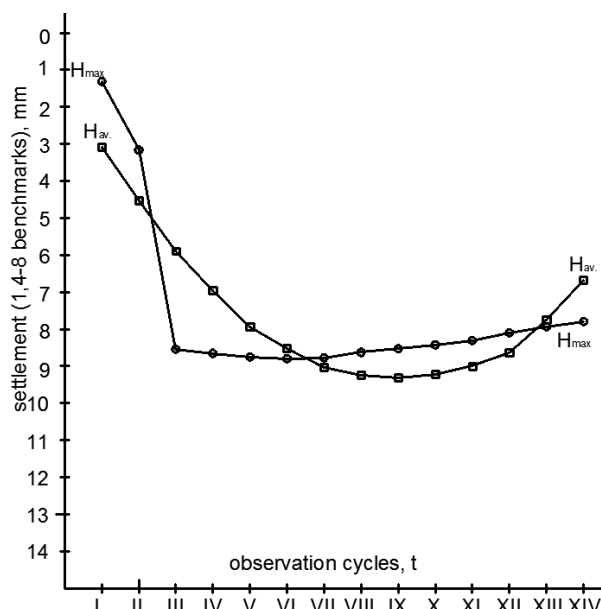
Fig. 17. The graph of the experimental and functional dependences of the benchmarks 1, 4-8

$$H = -0,1027t^2 + 1,817t + 1,352, \tag{3}$$

And average raising of the benchmarks 1, 4-8 stabilized and reached 0,1-0,2 mm.

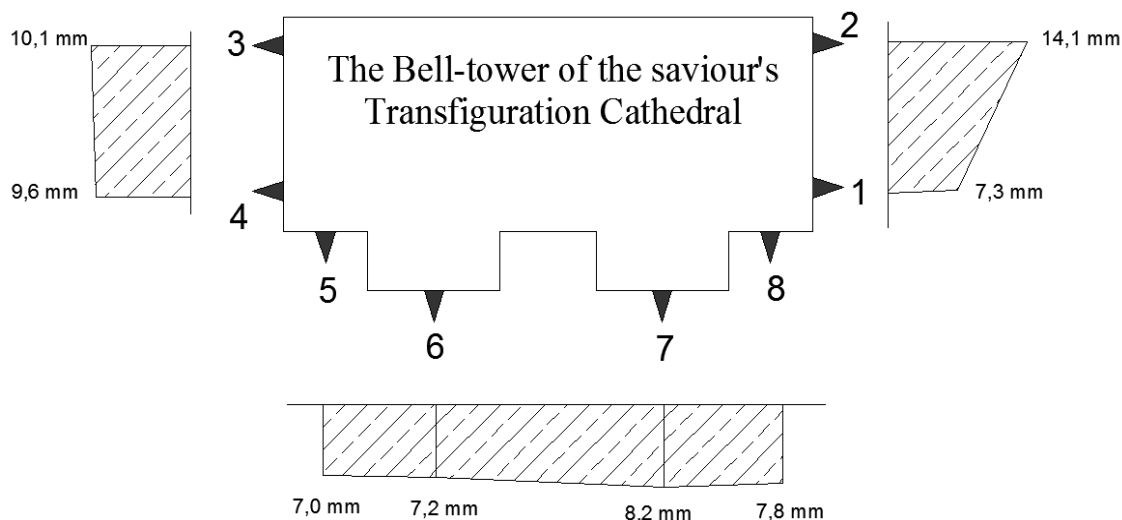
Fig. 18. A diagram of epures of the deformation benchmarks settlement during the entire period of observations, mm

The diagram shows epures of deformation benchmarks settlement as related to the first cycle of the observation (Picture 18). It is visible from this point that maximum settlement of the bell-tower footing is up to 14,1 mm, and minimum is – 7,0 mm [5, 7].
